SIO Shipyard Representative Bi-Weekly Progress Report		
Project: AGOR 28	Contract No.: N00014-12-C-0305	Shipyard: Dakota Creek Industries
Prepared by: Paul D. Bueren Scripps Institution of Oceanography (SIO) 297 Rosecrans St. San Diego, CA 98106	Date: 24 March 2016	Program Officer: Robert (Tim) Schnoor Office of Naval Research 875 Randolph St ONR 321 Arlington, VA 22203-1995
Distribution Statement A: Approved for public release; distribution unlimited.		Report No. A002.096

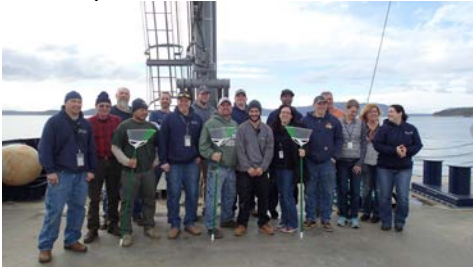
- AT completed!

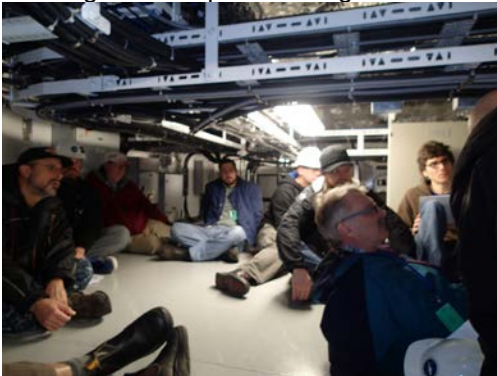
- **Crew Fam** – All complete except for 2-days of Mackey training as they failed to show up. Training will take place during FOA.
